Manhole Inspection Summary

Manhole # S53C__012MH

Insp Date: **6/12/08 9:16 AM**

Location Address: **rear 124 n clinton st**

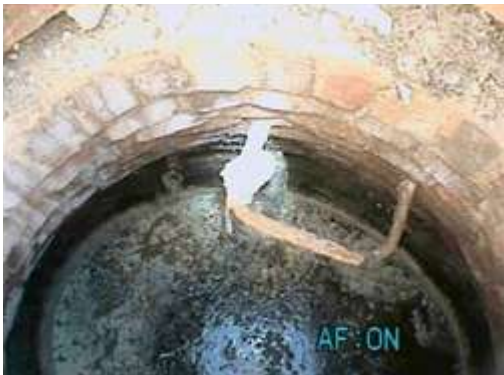
Defect 3

Steps Count: **2** Missing: **2** ☒ **Corroded**

Surcharge ☐ Evidence Of Surcharge Depth: **2.** (ft.) ☒ **Active Surcharge Present**

surcharge active, steps

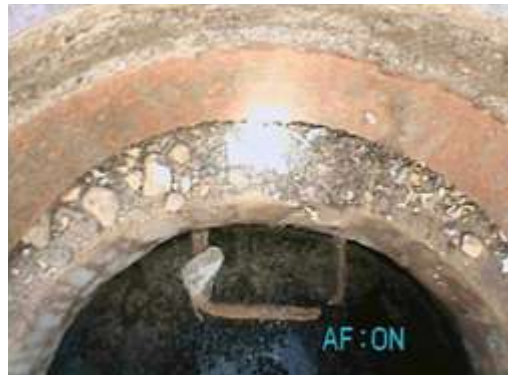
Defect 2

Frame Offset: **3** (in.) Condition: ☒ Sound ☐ Cracked ☐ Leaks

offset

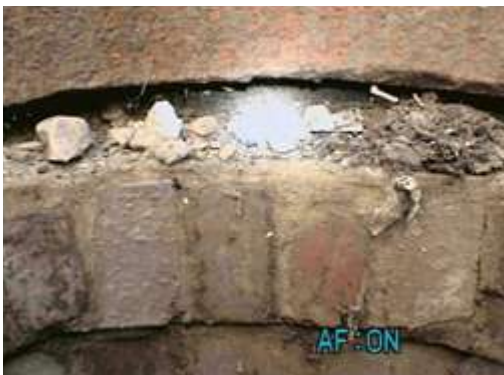
Defect 1

Chimney / Frame Adjustment ☒ Exists Material: **Brick and Concrete** ☐ Parged Height: **5** (in.)

Condition: ☐ Sound ☐ Cracked ☐ Root Intrusion ☐ Loose Brick ☒ **Deteriorated**

chimney deteriorated, frame adj
